National Transportation Safety Board Aviation Accident Preliminary Report

Location:	Ketchikan, AK	Accident Number:	ANC21FA069
Date & Time:	August 5, 2021, 10:50 Local	Registration:	N1249K
Aircraft:	DEHAVILLAND DHC-2 MK.I	Injuries:	6 Fatal
Flight Conducted Under:	Part 135: Air taxi & commuter - Non-scheduled - Sightseeing

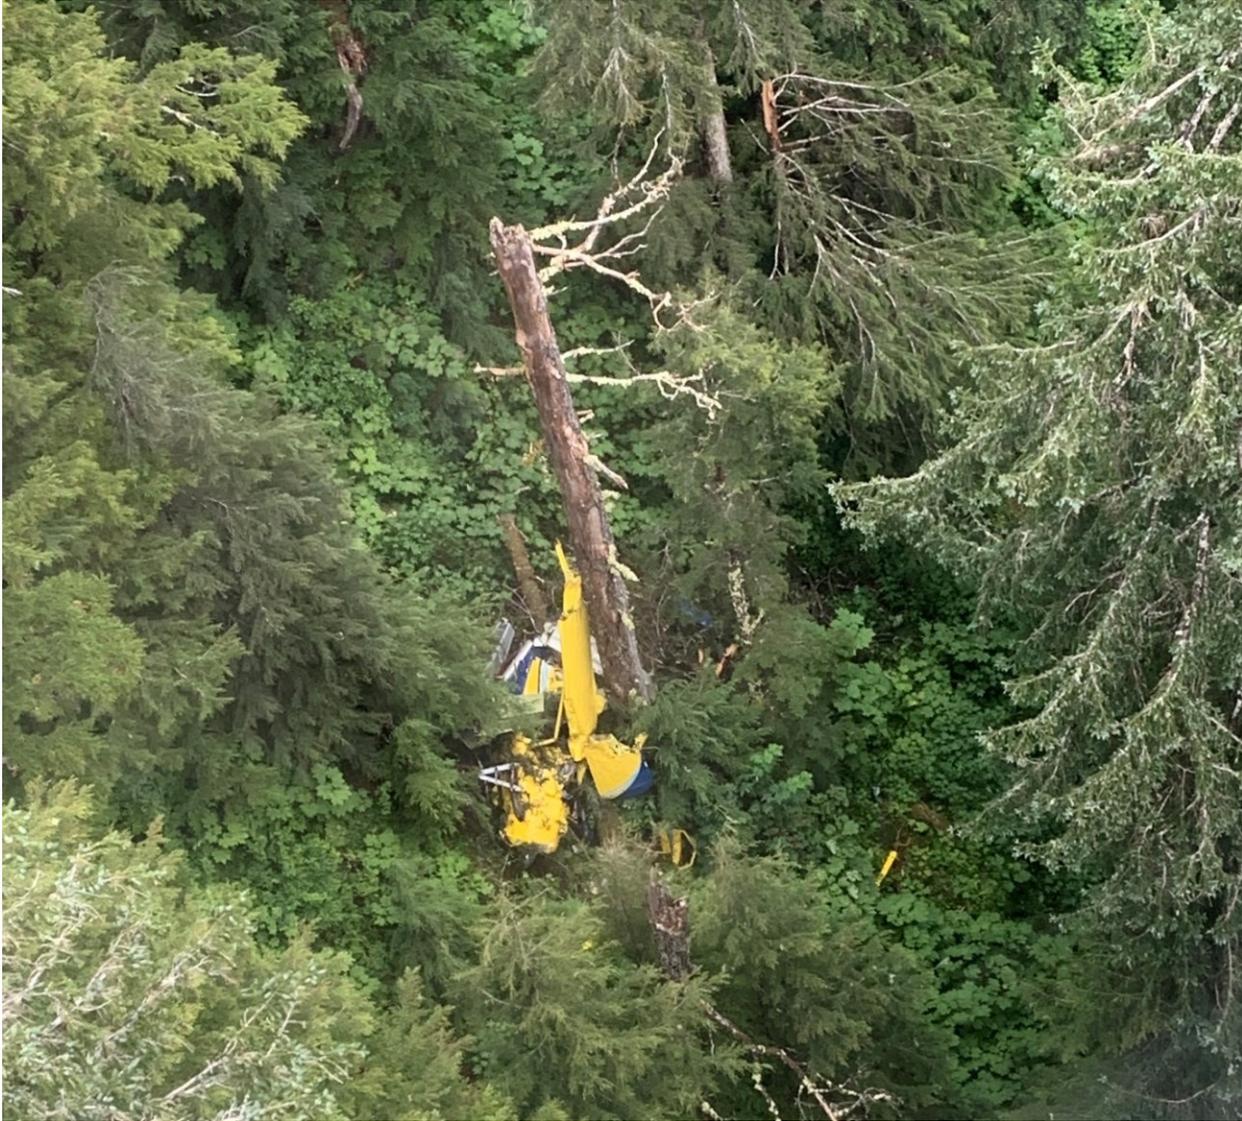
The airplane impacted heavily wooded, mountainous terrain about 18 miles northwest of Ketchikan, Alaska, and 1.46 miles from the last satellite tracking system point at an elevation of about 1,750 ft msl. The airplane initially impacted a tree about 435 ft from the main wreckage location, and the outboard section of the left wing was located at the base of the tree. The inboard section of the left wing was located in a tree along the debris path, which had a heading of 242°. All major components of the airplane were located in the vicinity of the main wreckage.

Figure 2. Aerial view of airplane at the accident site.

The fuselage came to rest on the left side and was impact crushed. The right wing remained attached to the fuselage. The outboard section of the right wing was impact separated but remained attached through a cable. The empennage remained attached to the fuselage and was impact damaged. The rudder and vertical stabilizer remained attached to the empennage, but the vertical stabilizer tip was separated. The left horizontal stabilizer and elevator were impact separated. The right horizontal stabilizer remained attached to the empennage and exhibited leading edge damage. The right elevator was impact separated. The floats were impact separated. The forward section of the left float was impact damaged. Flight control continuity was confirmed from the flight controls in the cockpit to all flight control surfaces.
