National Transportation Safety Board Aviation Accident Preliminary Report

Location:	Ketchikan, AK	Accident Number:	ANC21FA069
Date & Time:	August 5, 2021, 10:50 Local	Registration:	N1249K
Aircraft:	DEHAVILLAND DHC-2 MK.I	Injuries:	6 Fatal
Flight Conducted Under:	Part 135: Air taxi & commuter - Non-scheduled - Sightseeing

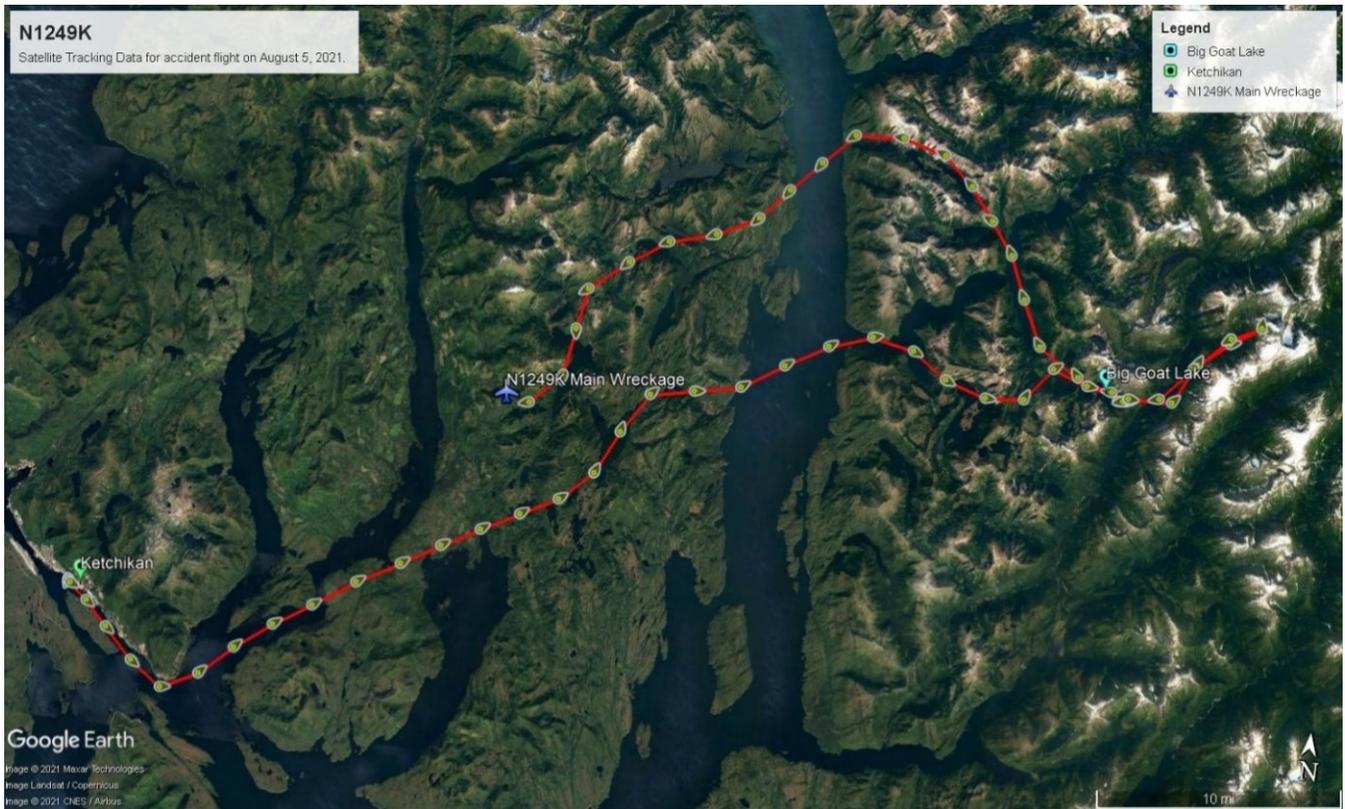
The airplane was equipped with a Spidertracks flight tracking system, which provides real-time aircraft flight tracking data. The flight tracking information is transmitted via Iridium satellites to an internet-based storage location, at one-minute intervals. The first part of the flight the airplane flew through the Misty Fjord Monument and landed on Big Goat Lake about 1018. Then at 1027, the airplane departed the lake and was en route to return to Ketchikan Harbor. The last satellite tracking system transmission from the airplane was at 1048; when the airplane was at an altitude of 1,730 ft mean sea level (msl) and on a ground track of 261° true.

Figure 1. Satellite Tracking Data for Accident Flight. Red line depicts route of accident flight and arrows point in the direction of travel.
